Evaluation of frictional wear in a follow-up screw-rod kinematic node in GGS transpedicular stabilization

Abstract

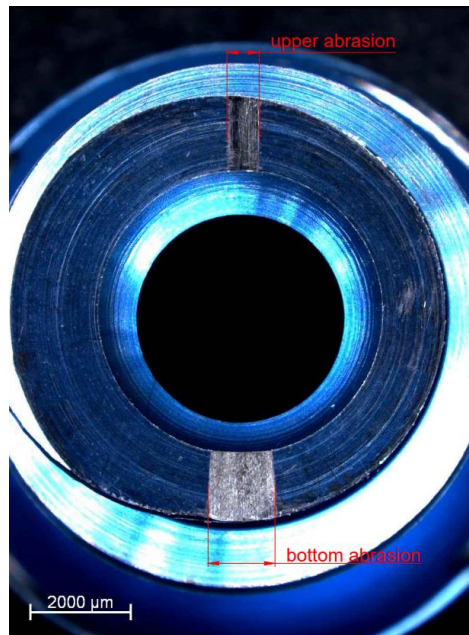
The experimental tests were followed by microscopic tests to evaluate the abrasive wear on the surface of the caps and rods. The microscopic analysis was performed using a Zeiss Stereo Discovery V20 stereo microscope (Zeiss, Oberkochen, Germany). The amount of abrasive wear on the caps was measured using AxioVision Rel. 4.8 software. Upper and lower abrasion (Fig. 4) was measured at four locations in the center of the abrasion.

Fig. 4. Abrasive wear of standard N4 cap with marked measurement of upper and lower abrasion.

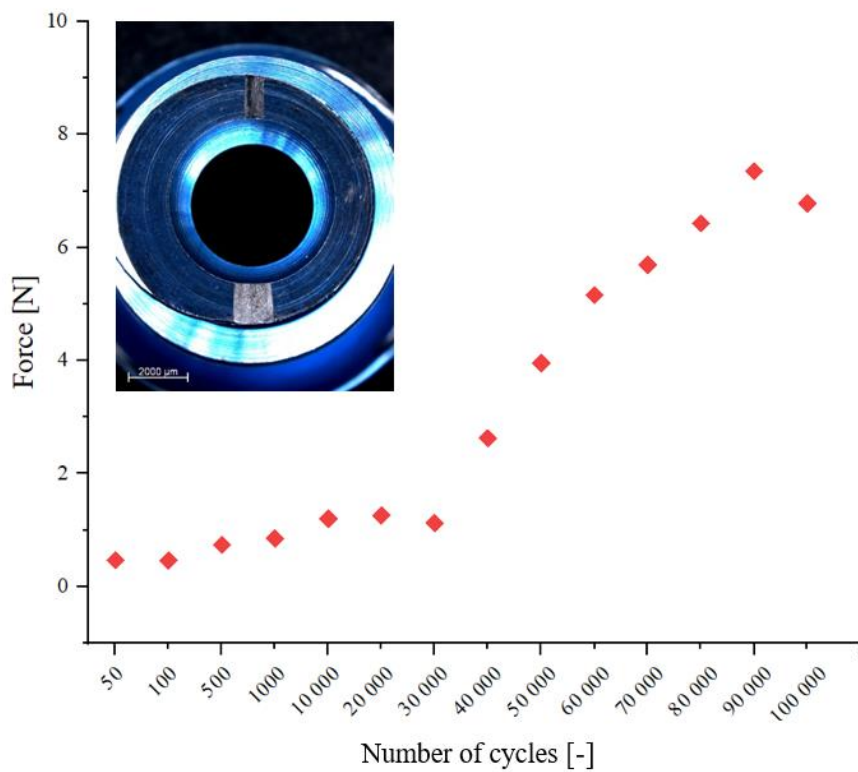
Graphs based on the results show the dependence of the maximum force on the number of loading cycles for various kinematic pairs. Characteristically, the force remains at 0.74 ± 0.15 N in the first 100 cycles and then increases to a maximum value of 10.1 ± 3.65 N. All kinematic pairs analysed showed a steadily increasing force with the increasing number of loading cycles. The increasing nature suggests that abrasive wear of the mating elements of the stabilizer occurred as the force increased. An example graph for the kinematic pair of cap N4 and rod P4 is shown below (Fig. 6).

Fig. 6. Example characteristics of the dependence of the maximum force on the number of load cycles for the kinematic pair N4-P4.

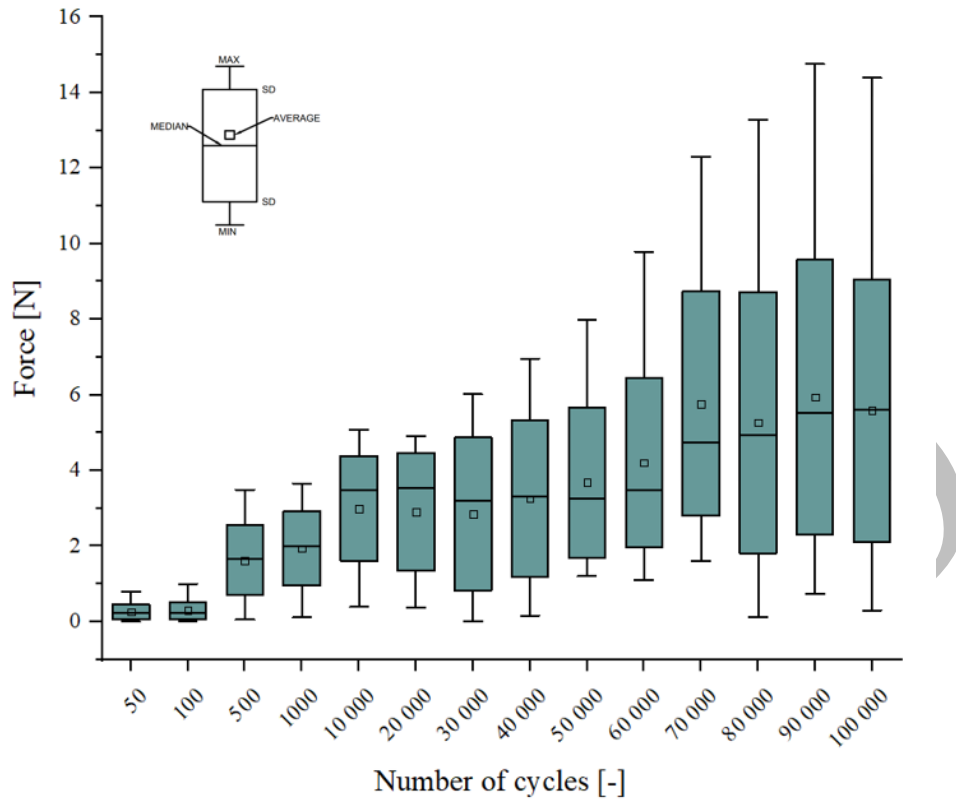
Fig. 7 shows the average value of the force in successive cycles for all kinematic pairs. The analysis of the entire test group shows an increase in force with an increase in the number of load cycles. The characteristics obtained may be relevant in terms of the degree of abrasive wear of the mating elements.

Fig. 7. Average value of the force in successive load cycles for all kinematic pairs.

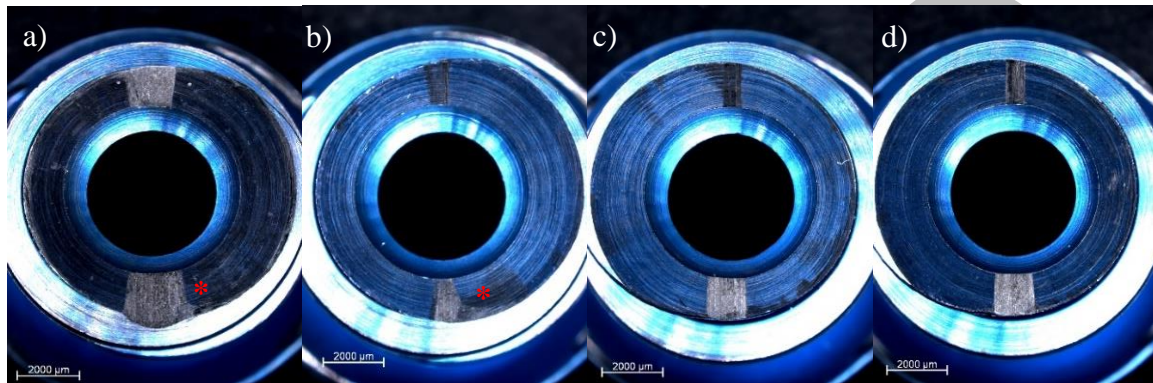
The mating of the cap-rod system resulted in abrasive wear visible on the surfaces of the mating elements. Table 3 shows the average upper and lower abrasion widths for all caps and the standard deviation determined. The average width of the upper abrasion is 784.4 ± 291.1 µm and the average width of the lower abrasion is 1267.3 ± 275.6 µm. The highest values were recorded for cap N1, with an upper abrasion width of 1280.9 ± 82.3 µm and a lower abrasion width of 1600.9 ± 67.4 µm. The highest forces were observed for the same kinematic pair, which may be a direct indication of increased wear and therefore greater abrasion. In all four cases, the size of the lower abrasion is larger than the upper one. In the case of caps N1 and N2, a small amount of material was chipped off at the bottom of the cap. Caps N3 and N4 suffered even wear with straight edges without any additional damage.

The photographs below show the traces of abrasive wear of the standard caps (Fig. 8) and the mating rods (Fig. 9).

Fig. 8. Traces of abrasive wear of the caps: a) N1; b) N2; c) N3; d) N4; the asterisk marks the place of chipping of the material in caps N1 and N2.

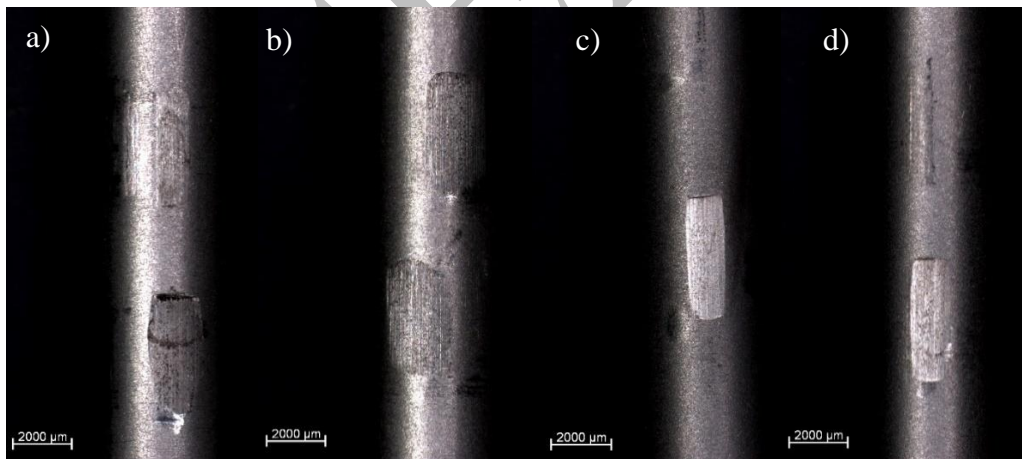
Fig. 9. Traces of abrasive wear of the rods: a) P1; b) P2; c) P3; d) P4.

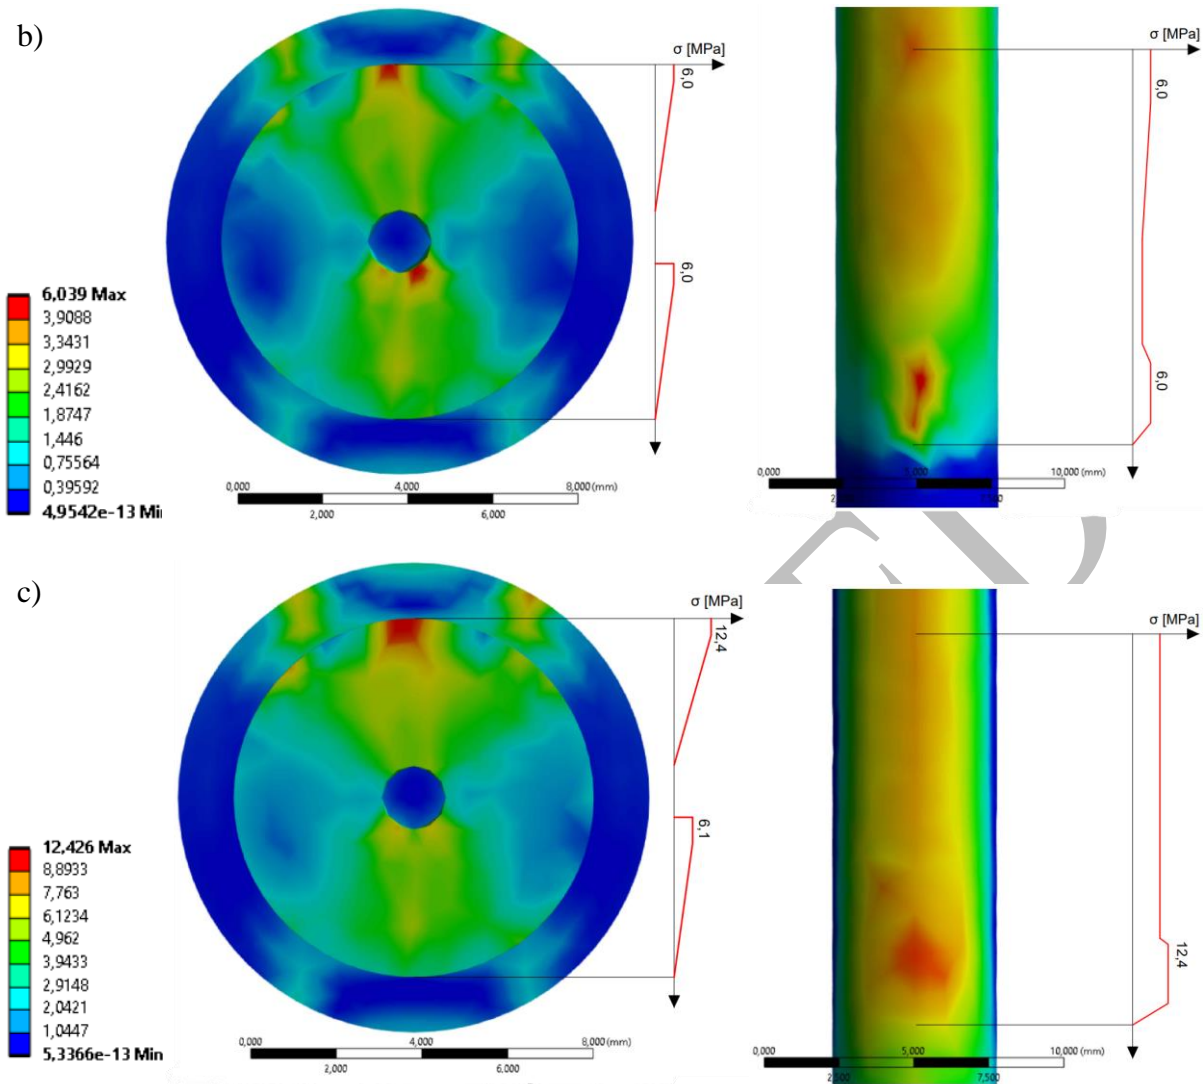
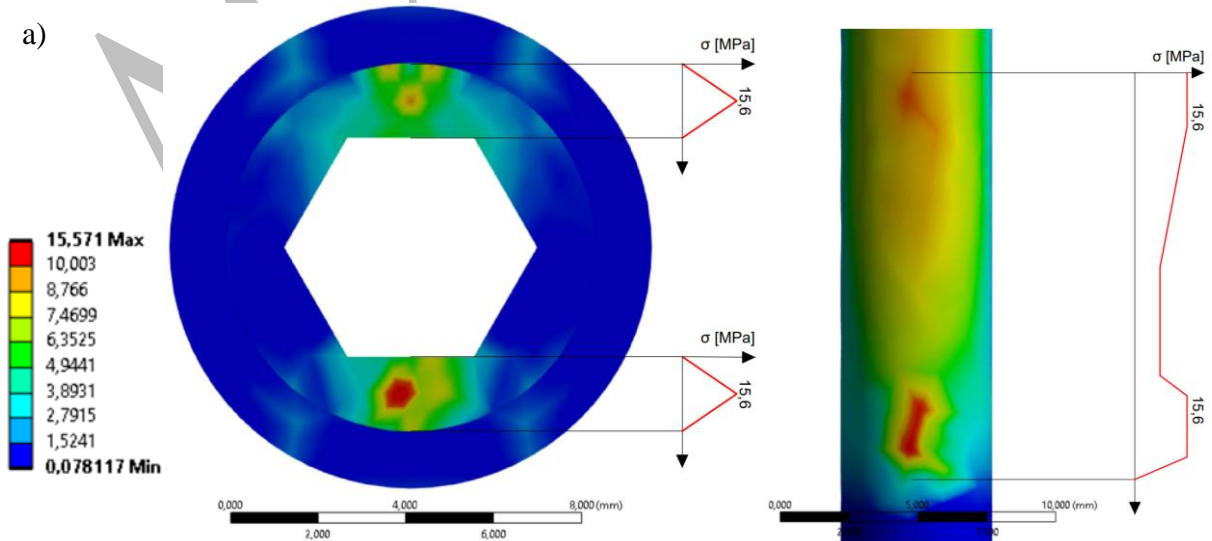
Fig. 10a shows the distribution of the reduced stresses according to the Huber-von Mises hypothesis for the cap and rod, the kinematic pair reproducing the experimental tests. Increased stresses of approximately 16 MPa can be seen at the top and bottom of the cap, corresponding to the upper and lower abrasion (Fig. 8), which occurred in the experimental tests for this group. The stress concentration areas reproduce the actual operation of this joint. This is the contact area between the rod and the cap. Their movement fit causes increased wear at these areas. It can be seen that a larger area of stress concentration occurs at the bottom of this element. In contrast to the kinematic pair without structural change, the rod in the other models mated directly with the insert and not the cap. The cap had an additional hole in which the insert pin was placed. In both cases, stress concentrations were observed around the pin hole. The stresses reach up to 6 MPa in the model with the PE insert (Fig. 10b) and up to 12 MPa in the pair with the PEEK insert (Fig. 10c). In the kinematic pair reproducing the experimental tests, the highest stresses for the rod were recorded at the contact points with the cap. Two areas of stress concentration were observed: at the contact points of the top and the bottom with the cap. The maximum values (approximately 16 MPa) are located at the bottom of this element (Fig. 10a). The kinematic pairs with the structural change have a different distribution. The stresses are distributed in the area resulting from the contact between the rod and the additional insert. The kinematic pair with the PEEK insert showed lower stresses (approximately 12 MPa) (Fig. 10c). Similarly, in the case of the model with the PE insert, the highest stresses (approximately 6 MPa) are located in one small area resulting from the contact between the elements (Fig. 10b).

Fig. 10. Huber-von Mises stress distribution of the cap and the rod in the pair: a) without a structural change reproducing experimental tests; b) with PE insert; c) with PEEK insert.

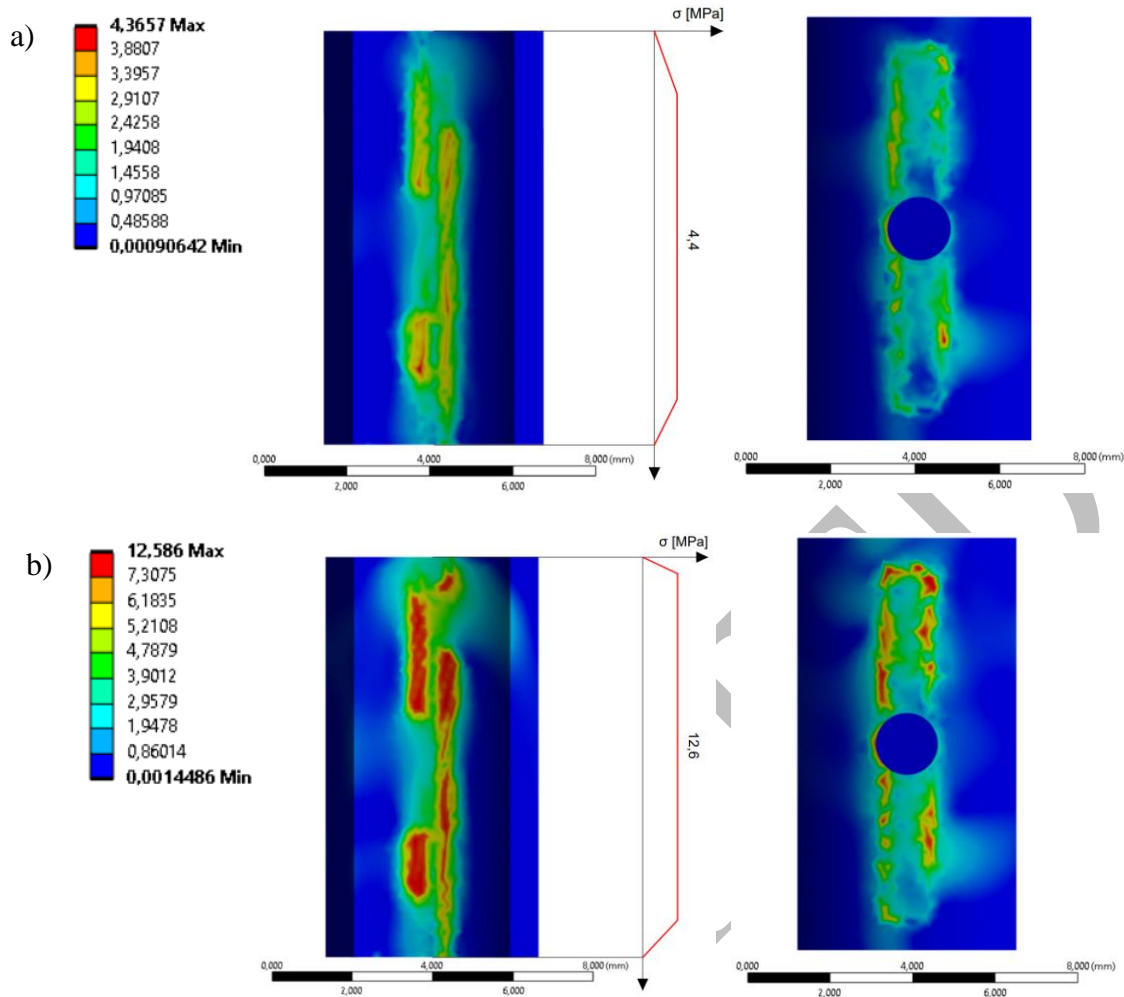
The distribution of reduced stresses according to the Huber-von Mises hypothesis of the PEEK and PE inserts is shown in Fig. 11. The analysis of both elements shows that stress concentrations occur in the central part of the insert along its entire length. The stresses are also located on the other side, around the pin that allows the element to be mounted. The maximum values reach approximately 13 MPa for the kinematic pair with PEEK insert and approximately 4 MPa for the model with PE insert. Their distribution is strongly related to the operation of the element. It mates with the moving rod. Visible areas of concentration could indicate the formation of abrasive wear at this location.

Fig. 11. Huber-von Mises reduced stress distribution for: a) PE insert; b) PEEK insert.
